AFWAL-TR-87-4011

RESEARCH ON MECHANICAL PROPERTIES
FOR ENGINE LIFE PREDICTION

UNIVERSITY OF DAYTON
RESEARCH INSTITUTE
DAYTON, OHIO 45469

INTERIM REPORT FOR PERIOD COVERING
1 AUGUST 1985 THROUGH 31 JULY 1986

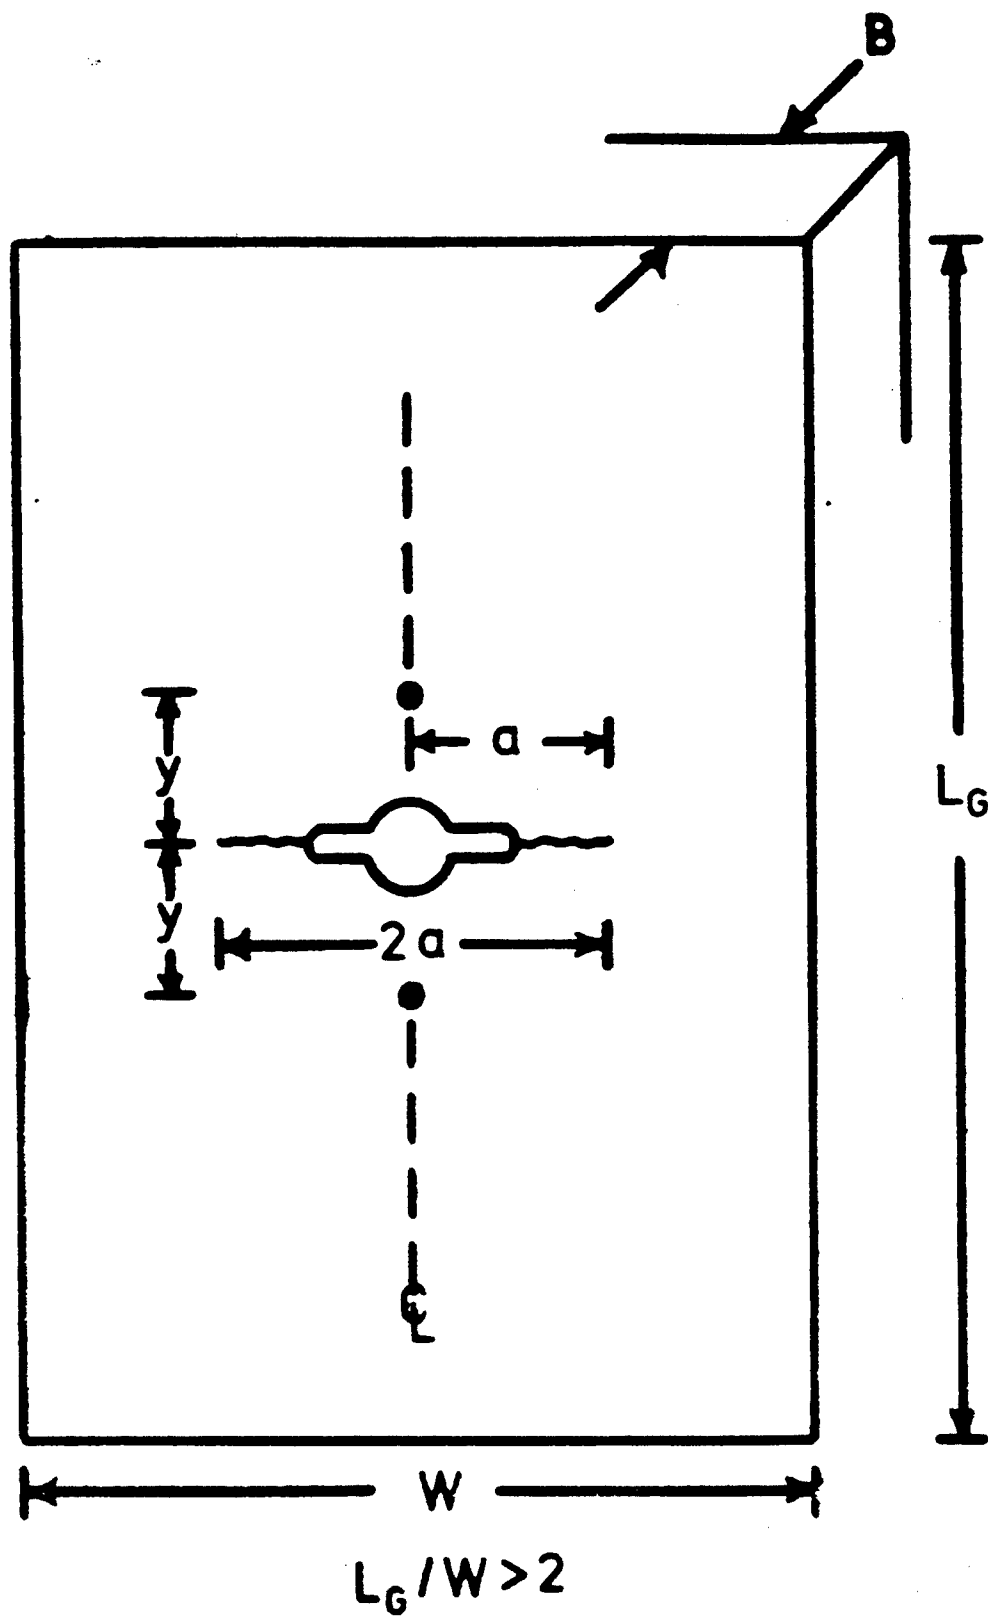
Figure 1. Center-Cracked Tension Specimen-M(T).

The object of this investigation was to formulate a wide-range solution for crack length of a center cracked specimen, $M(T)$, as a function of compliance, displacement measurement location, and Poisson's ratio. A schematic showing the geometric parameters of an $M(T)$ specimen is given in Figure 1. The total crack length is $2a$ and the nominal distance between the locations for the displacement measurement is $2y$. W is the width of the specimen, B is the specimen thickness, and E is Young's modulus. The compliance, C , is the inverse of the slope of the linear portion of the load versus displacement curve.

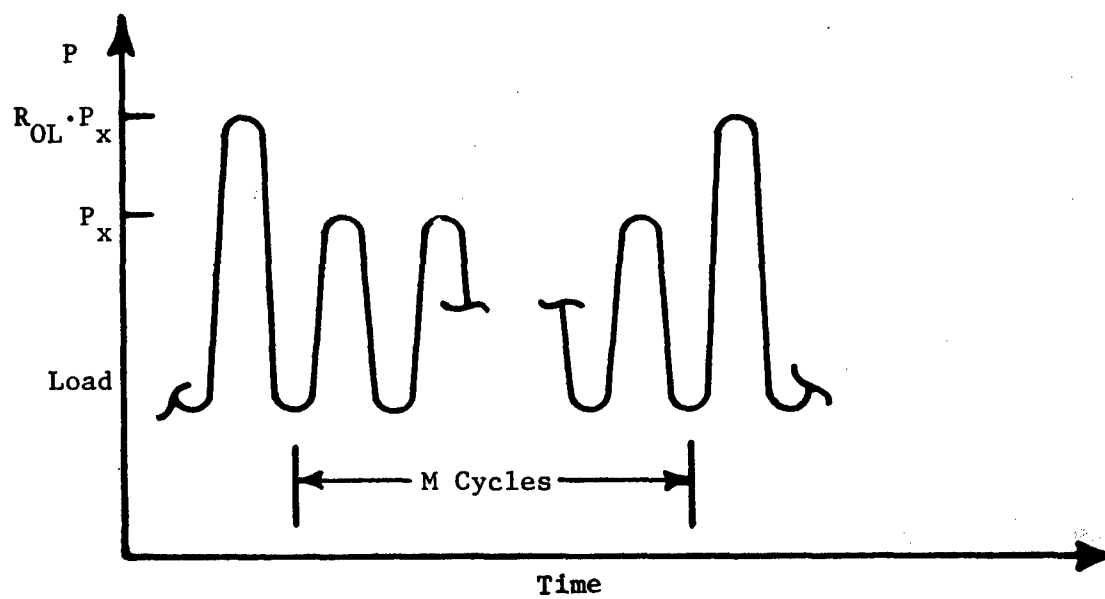
Figure 2. Periodic Single Overload Spectrum.

In previous work [2], software was developed to conduct an automated crack growth test under a periodic single-overload fatigue spectrum. A schematic of the applied load and the parameters that describe the load spectrum are shown in Figure 2. Several modifications were made to the software to support several research projects.

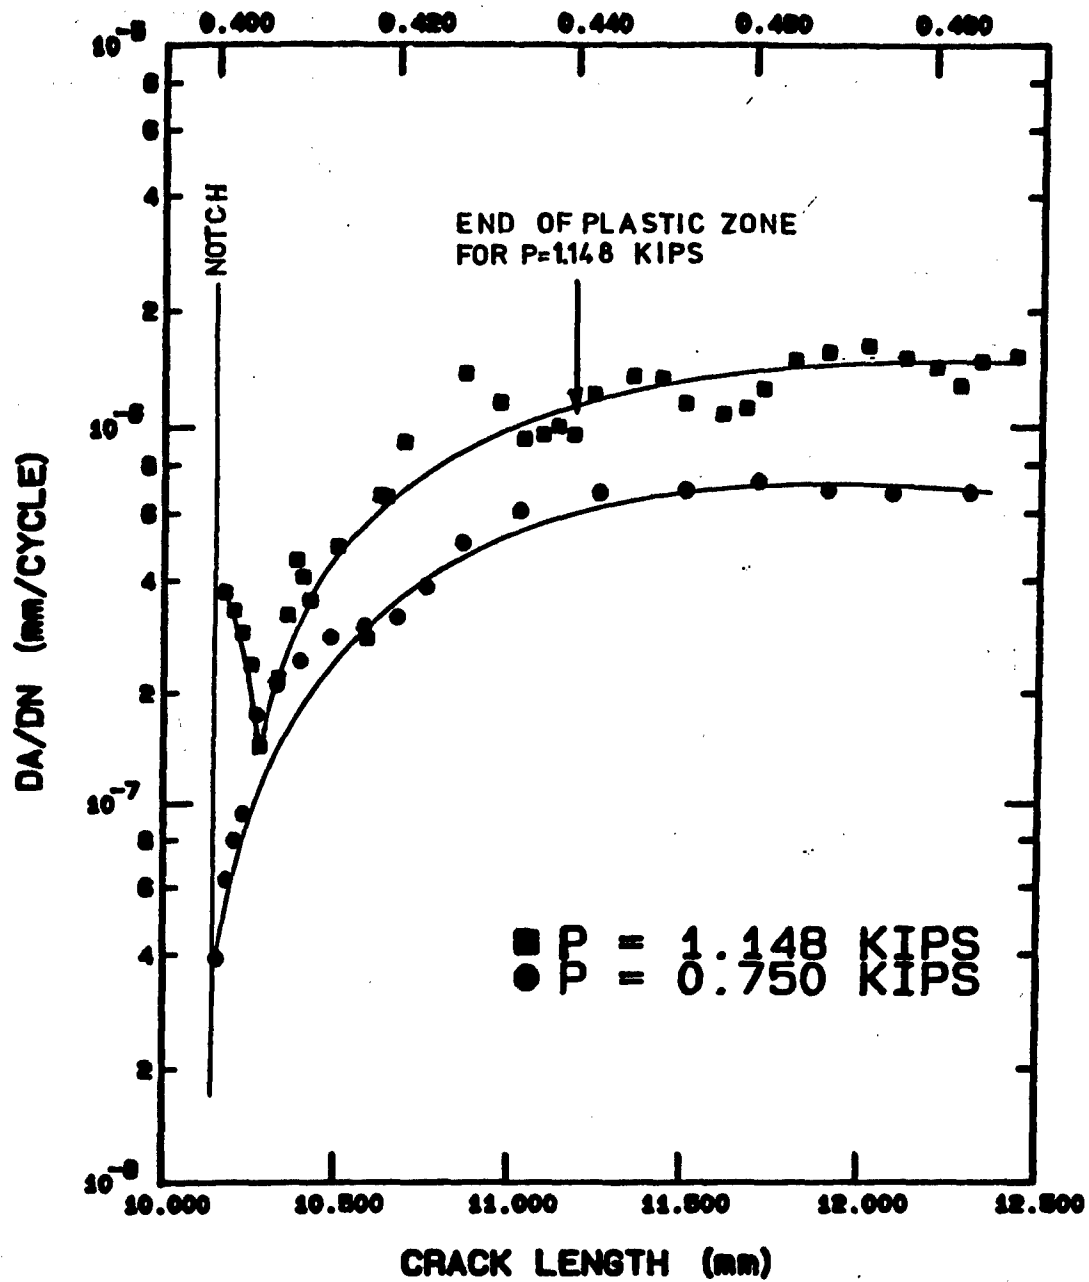
Figure 3. da/dN vs. Crack Length Behavior of Crack Growing From a Notch.

The crack growth tests were conducted at two different load levels of 1,150 lbs. and 574 lbs. These loads were chosen to create two conditions - a notched plastic zone produced by higher load and an unaffected one (negligible plastic zone) by the lower load. Since a crack could not be initiated at 574 lbs. in the first few tests, the load was increased to 750 lbs. According to calculations, a very small zone of plasticity at 750 lbs. is created at the notch but the size of this plastic zone is expected to be smaller than the length of the smallest crack that could be measured. In this case, the crack growth rates were measured outside the plastic zone of the notch and cracks were grown until

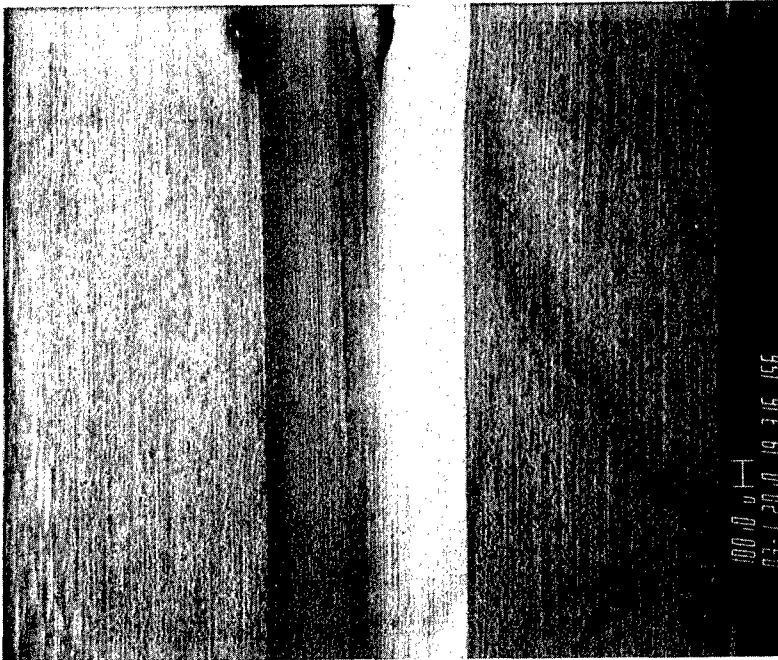
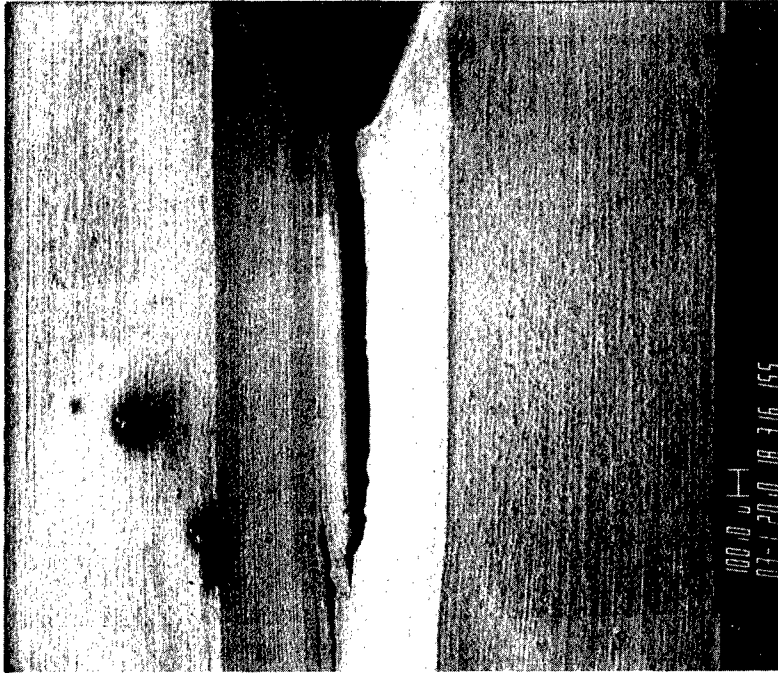
Figure 4. Crack Layering.

a. Low Magnification Picture Showing Crack Layering Ahead of Crack Tip.

b. Higher Magnification of Crack.

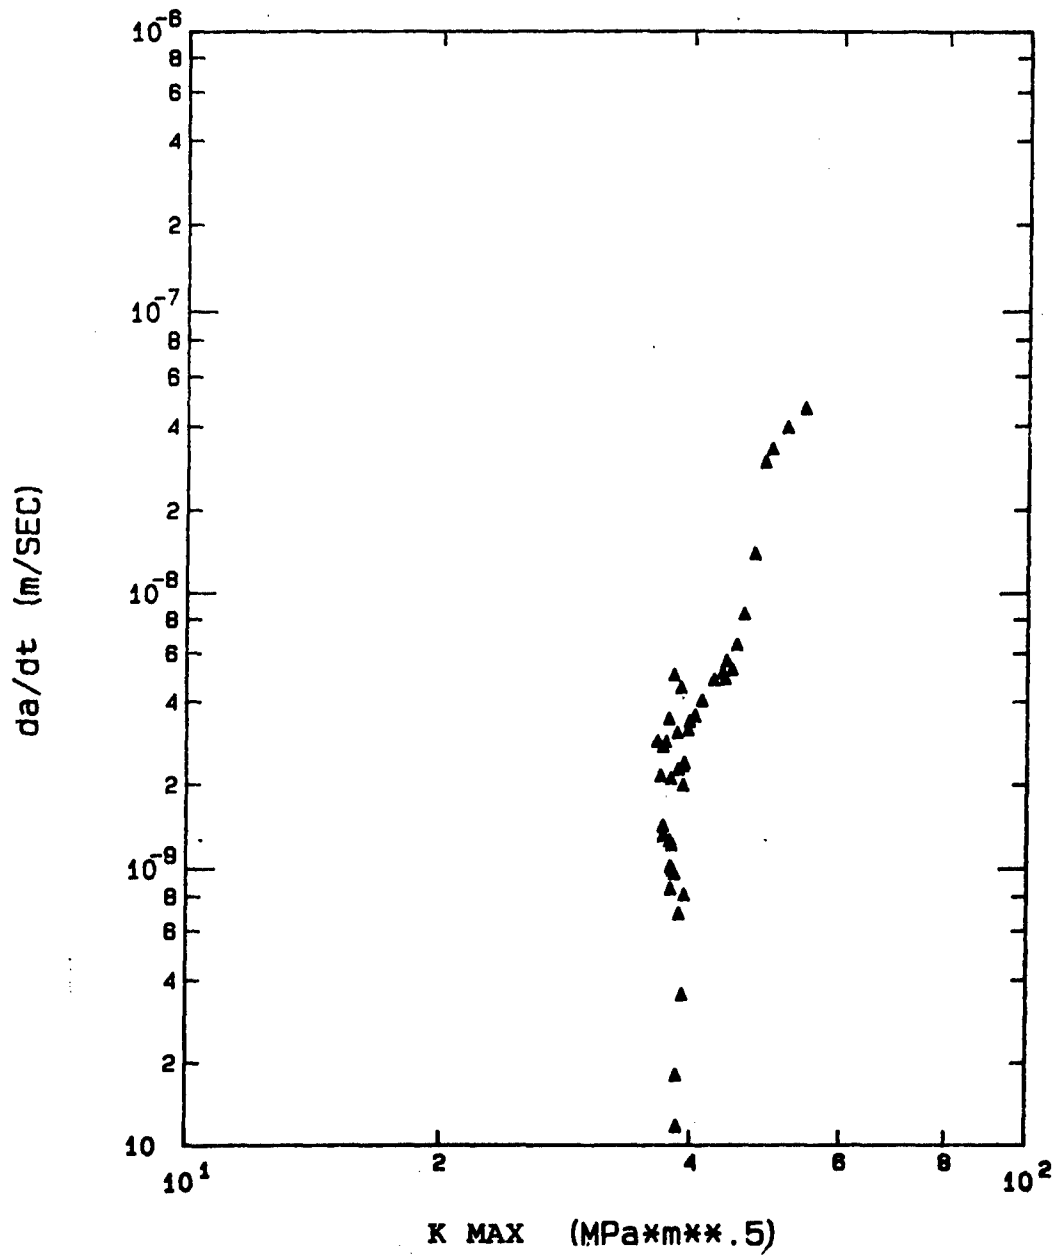
Figure 7. da/dt vs. K_{max} for 0.4-Inch-Thick IN718 Specimen Tested at 1200°F in Vacuum.

evaluate the influence of specimen thickness. The test results from the thicker SEN specimens are shown in Figure 7. The CCG behavior is very similar to that obtained earlier [9] with 0.20-inch thick specimens. Apparently, the effect of specimen thickness is negligible over this range of specimen thickness.

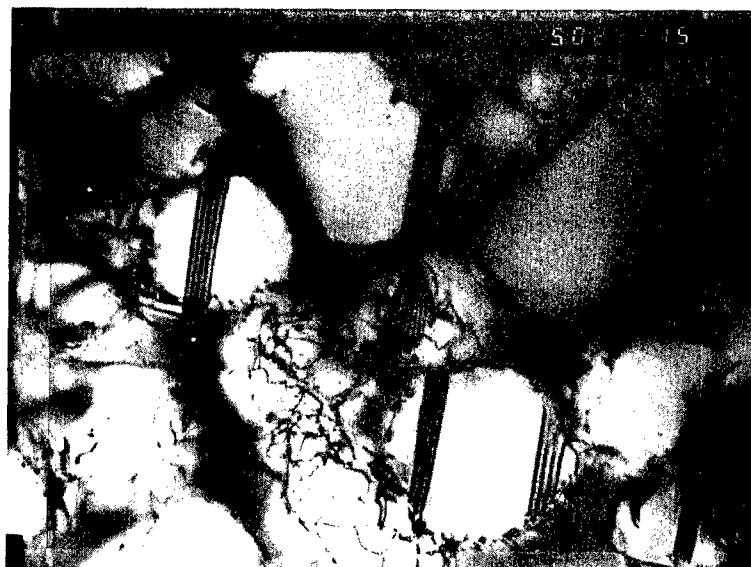
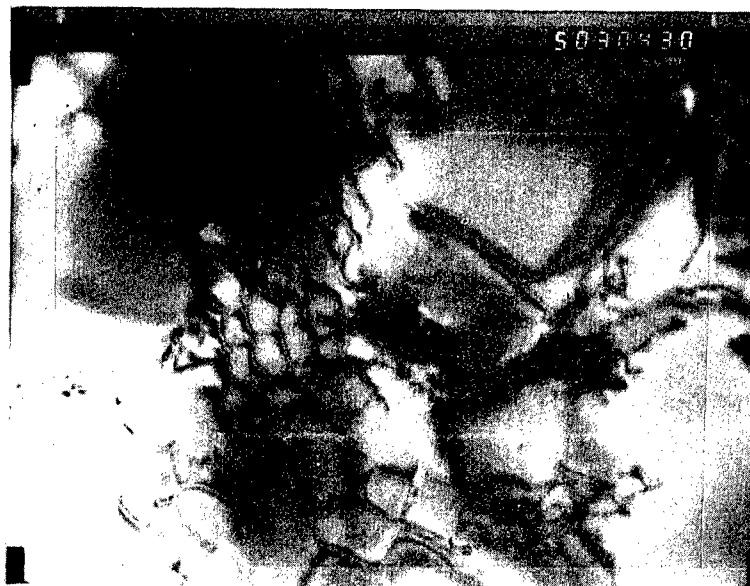
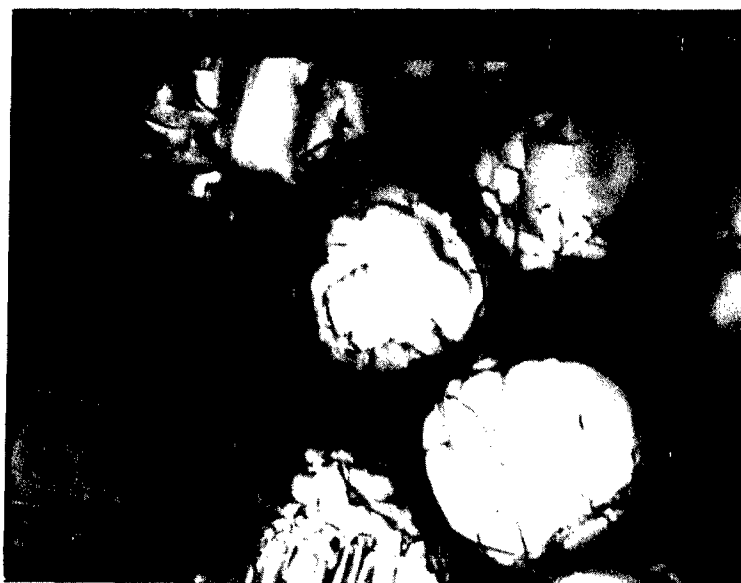
Figure 10. Substructure Developed at 0.86% Creep Strain Tested at 1600°F.

At a strain of 0.86 percent, which lies in the initial stage of steady-state creep, the development of faults in the precipitate is noticed, as shown in Figure 10(a). At the same time, with increased strain, dislocation interaction leads to the formation of a dislocation network at the interface, as shown in Figure 10(b). Some of the dislocations can be seen entering the precipitate, as shown in Figure

a. Stacking Faults with Precipitate.

b. Dislocation Network at the Interface.

c. Dislocation Migration into Precipitate.

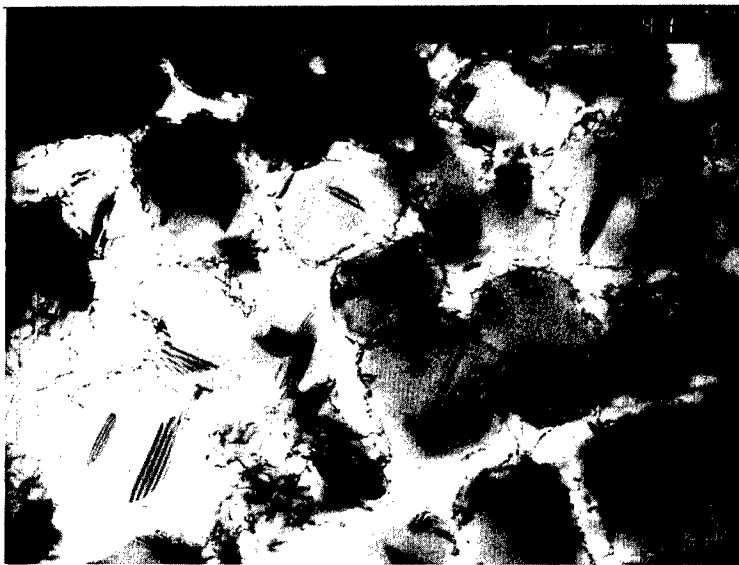
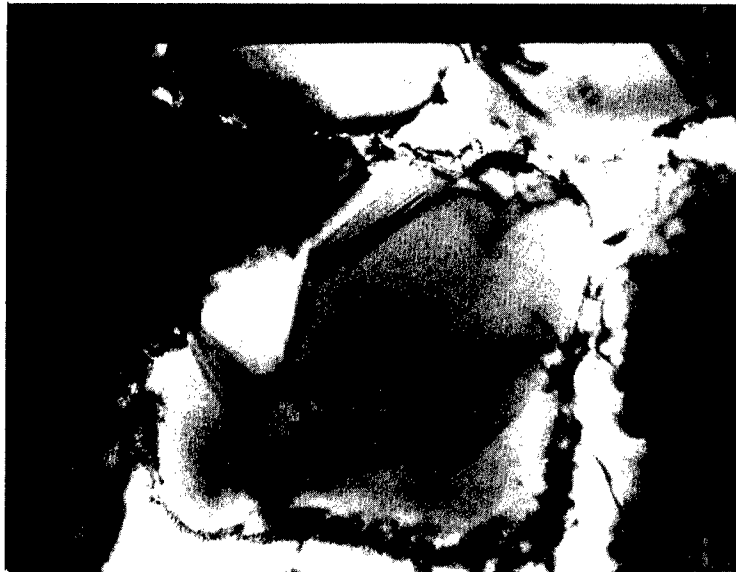
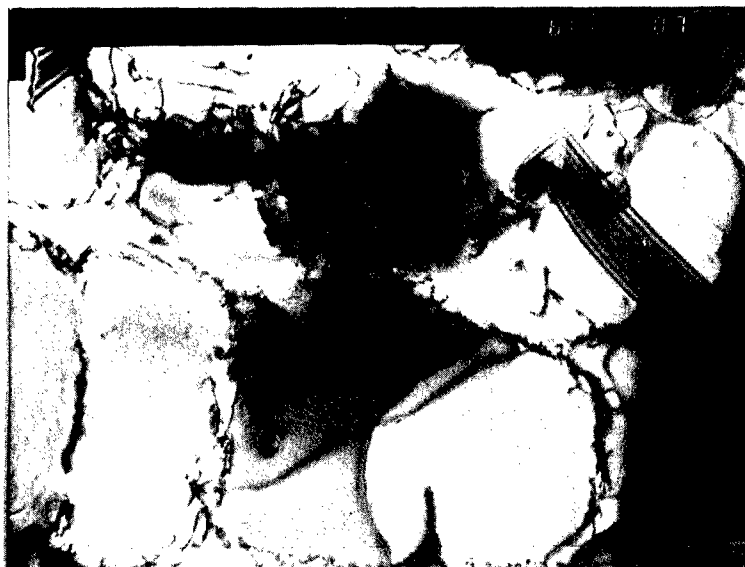
Figure 11. Substructure Developed at 2.5% Creep Strain Tested at 1600°F.

The dislocation activity intensifies with increased deformation and the general substructural feature of a specimen strained up to 2.5 percent is shown in Figure 11(a). The increase in stacking faults as well as dislocation density is clearly noticed. Figure 11(b) provides another TEM micrograph from the same specimen showing a super pair entangled with stacking faults. The shear or cutting of the gamma prime precipitate by a super dislocation is shown in Figure 11(c). These dislocations were analyzed through the $\bar{g} \cdot \bar{b} = 0$ criterion (where \bar{g} is the reflecting plane vector and \bar{b} is the dislocation Burger's vector), and found to be $a/2 \langle 110 \rangle$ type.

a. High Density of Stack Fault.

b. Super Pair Entangled with Stacking Fault.

c. Precipitate Shear by Super Pair.

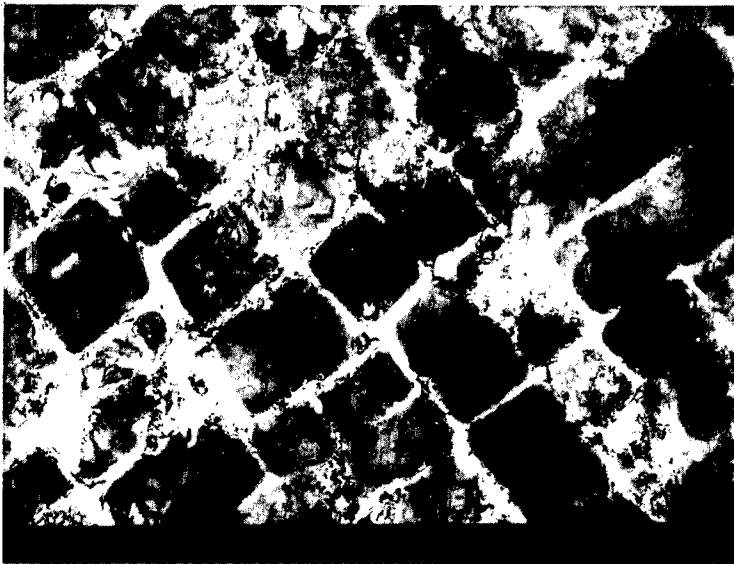
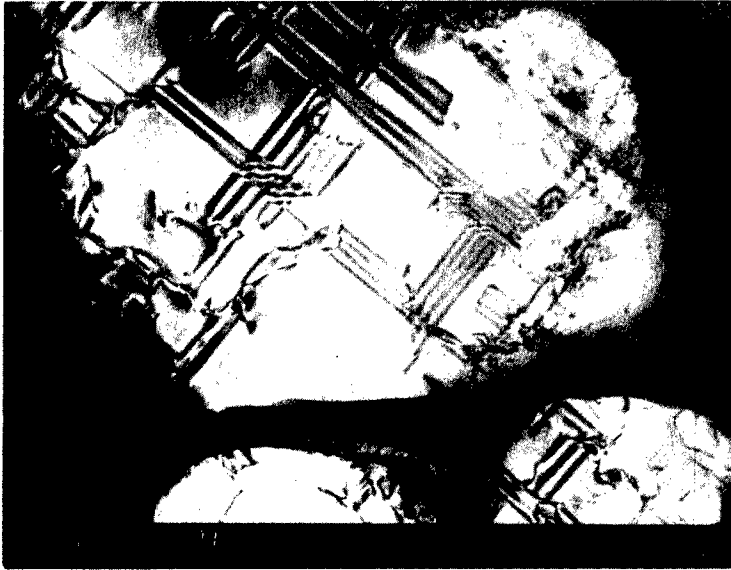
Figure 13. Substructure Developed in the Creep Ruptured Specimen at 1400°F.

Thin foils were prepared from specimens that experienced creep rupture at 1400°F, 1600°F, 1800°F, and 2000°F under sustained loadings of 100 ksi, 65 ksi, 30 ksi, and 12.5 ksi, respectively, to investigate the difference in creep morphology with temperature. Figure 13(a) is a low magnification (20,000X) TEM micrograph showing heavily faulted structure of the specimen failed at 1400°F. Most of the dislocation activity is confined to the precipitate, and the precipitate shear appears to occur by the glide of $a/3 \langle 112 \rangle$ partial dislocations. The faulted structure can be seen more clearly in Figure 13(b), where two sets of faults can be easily distinguished. Similar faulted substructure is observed in the foil prepared from specimens failed at 1600°F. At 1600°F, two sets of microtwins were also observed. One such set of microtwins is shown in Figure 14(a). Although as clear, the microtwin activity on the other set of planes is shown in Figure 14(b). There are some indications that the intersection of such microtwins act as a crack nucleation site. This phenomenon has been observed only at 1600°F and it is postulated that the microtwins are formed by a cooperative stacking of faults.

a. High Density of Faults.

b. Two Sets of Faults in the Precipitate.

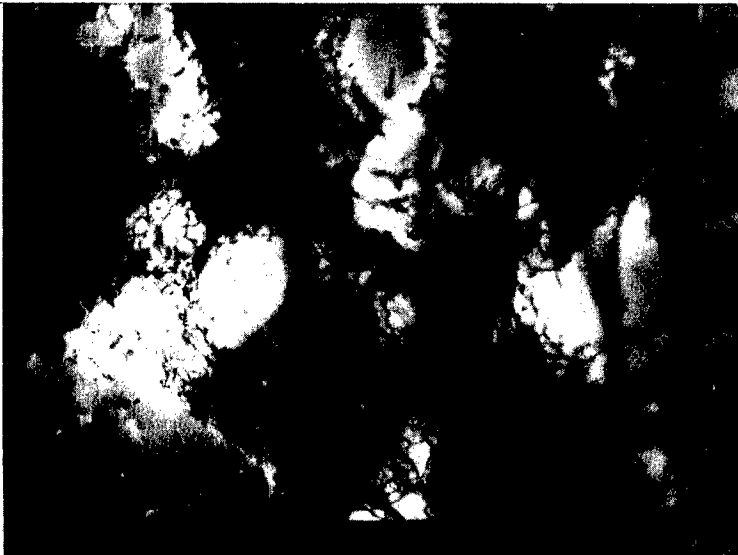
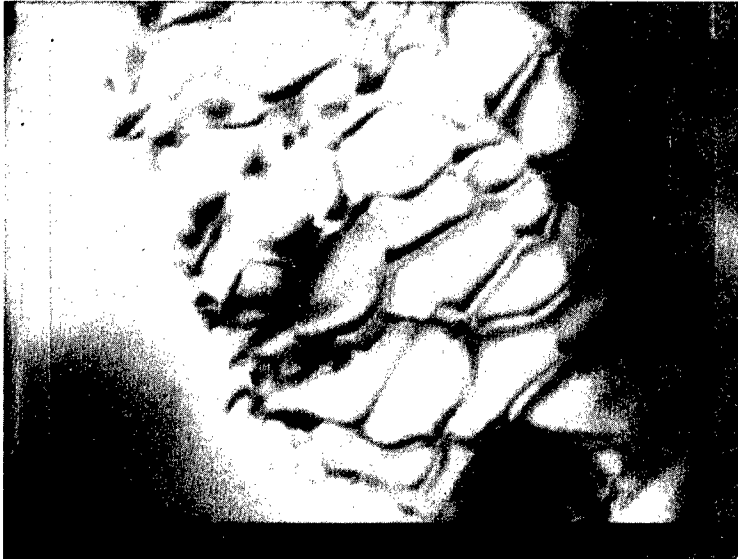
Figure 15. Substructure Developed in Creep-Ruptured Specimen at 1800°F.

The substructure is somewhat different for specimens tested at 1800°F. The formation of cells in these substructures is quite evident as shown in Figure 15(a), and hardly any fault is noticed. The cell walls are made up of networks of super pairs of $a/2 \langle 110 \rangle$ dislocations as shown in Figure 15(b). Such dislocation pairs can be seen within the precipitate also, as discussed earlier. In contrast to the deformation

a. Cell Structure.

b. Network of Super Pair Dislocation.

c. Super Pair Dislocation in Precipitate.

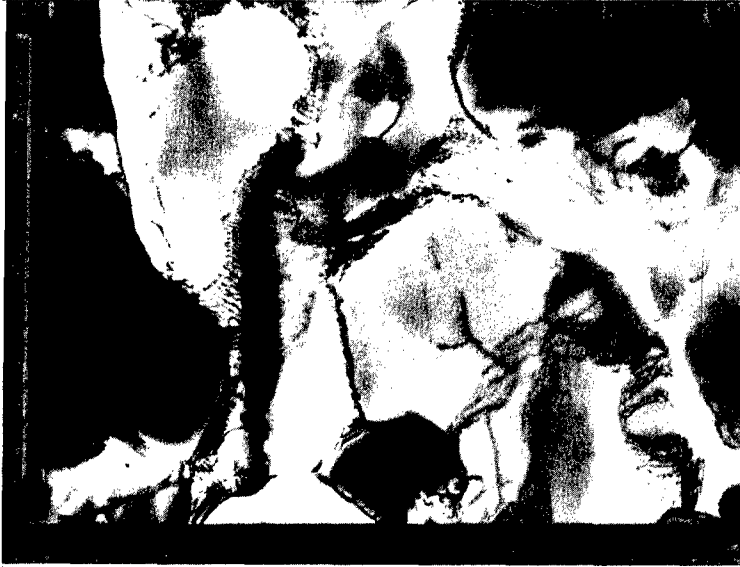
Figure 16. Substructure Developed in Creep-Ruptured Specimen at 2000°F.

a. Cell Structure.

b. High Magnification of Cell Structure.

c. Cell Development Within Precipitate.

d. $a/2 \langle 110 \rangle$ Super Pair in Cell Wall.

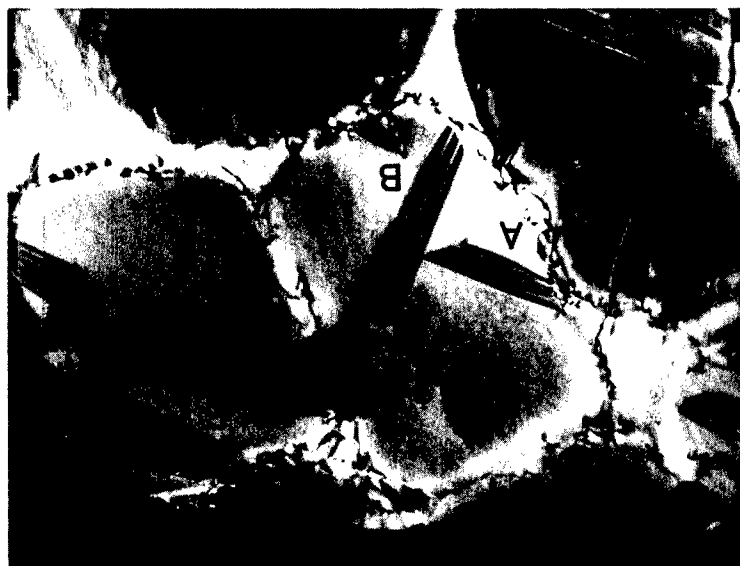
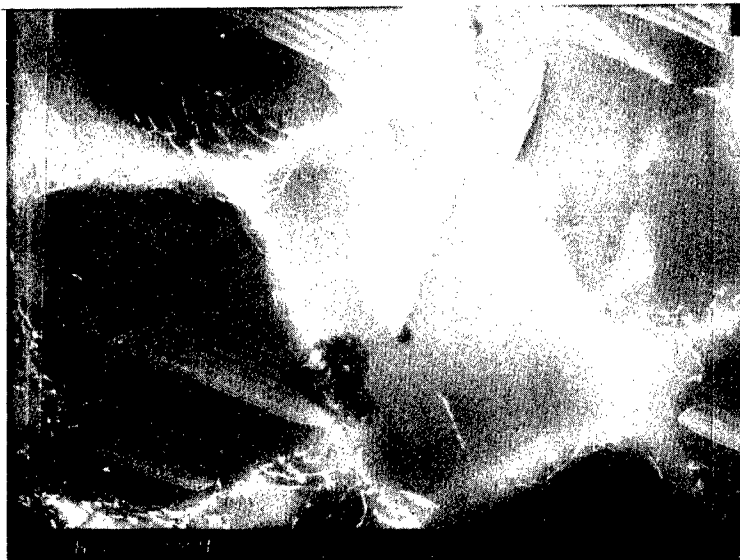
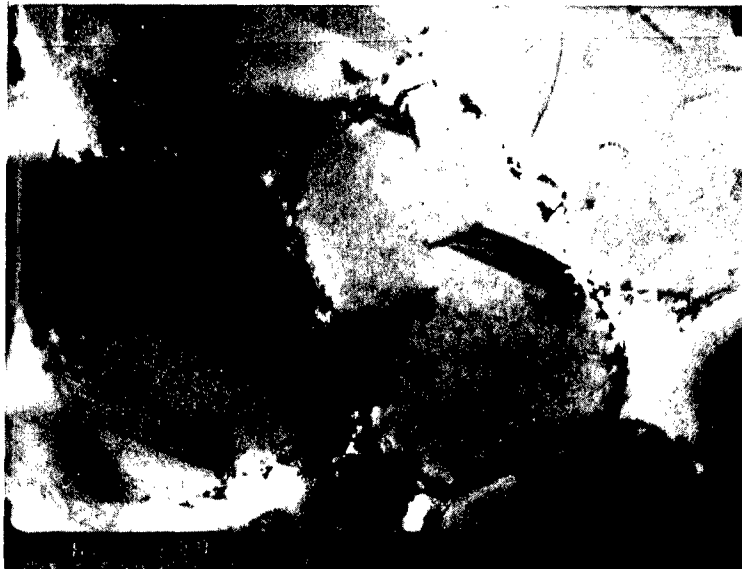
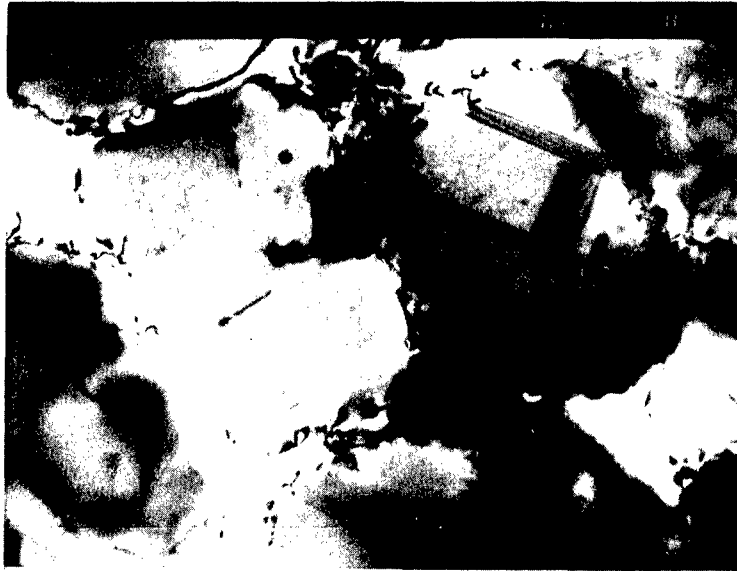
Figure 17. Different Sets of Stacking Faults Developed at 1600°F.

A simple analysis of the stacking faults observed at 1600°F was conducted using the $\bar{g} \cdot \bar{R} = 0, 1, \text{etc.}$, criterion (where \bar{g} is the reciprocal vector and \bar{R} is the displacement vector) to understand the glide mechanism operating. Figure 17(a) shows different sets of stacking faults obtained from a specimen creep ruptured at 1600°F and 65 ksi. The dark field image of these faults is shown in Figure 17(b). For some of these faults, e.g., A and B, the extreme fringes differ in sense; one is bright and the other is dark, indicating that the dislocation form intrinsic/extrinsic faults. Again for a particular reflection of $\bar{g} = 200$, all the stacking faults (A to E) are visible as shown in Figure 17(a). The stacking faults A, C, and E, are, however, invisible for $\bar{g} = \bar{2}20$, as shown in Figure 17(c), indicating the fault plane to be $(11\bar{1})$. These stacking faults were found to be invisible for $\bar{g} = 220$ also.

The faults B and D are invisible for $\bar{g} = 2\bar{2}0$ as shown in Figure 17(d), indicating that these faults lie on $(1\bar{1}1)$ plane. Furthermore, the faults A and B both are invisible for $\bar{g} = 311$, as shown in Figure 17(e). Confirming the fault planes of A and B to be $(11\bar{1})$ and $(11\bar{1})$ - this analysis indicates that the deformation process involving the creation of stacking faults is occurring at least on two different sets of (111) plane.

a. Bright Field Image.

b. Dark Field Image.

c. Faults A, C, and E Invisible
for $\bar{g} = 220$.

d. Faults B and D Invisible for
 $\bar{g} = 220$.

e. Faults A and B are Invisible for $\bar{g} = 311$.
